2022 California Battery Energy Storage System Disturbances

California Events: March 9 and April 6, 2022
Joint NERC and WECC Staff Report

September 2023

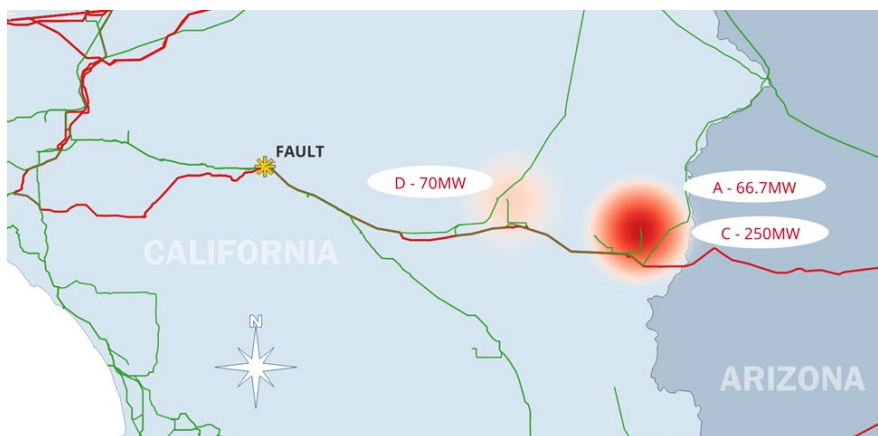
Figure 1.1: Map of the Fault Location and Affected IBR Facilities—March 9, 2022

- **March 9, 2022:** At 18:03:20 Pacific time, a generator bus was faulted when a generator circuit breaker had an internal failure at a natural-gas-fired, simple-cycle facility in Riverside County, California, causing a C-phase-to-ground fault on the 220 kV system. Generator units relayed, disconnecting the natural gas generators that were carrying 694 MW. The fault was cleared in approximately 4.5 cycles. In addition, inverter-based resources from many different facilities also unexpectedly reduced 408 MW, 124 MW of which is attributed to BESS. The fault therefore resulted in a total loss of 1,102 MW of generation, and system frequency dropped

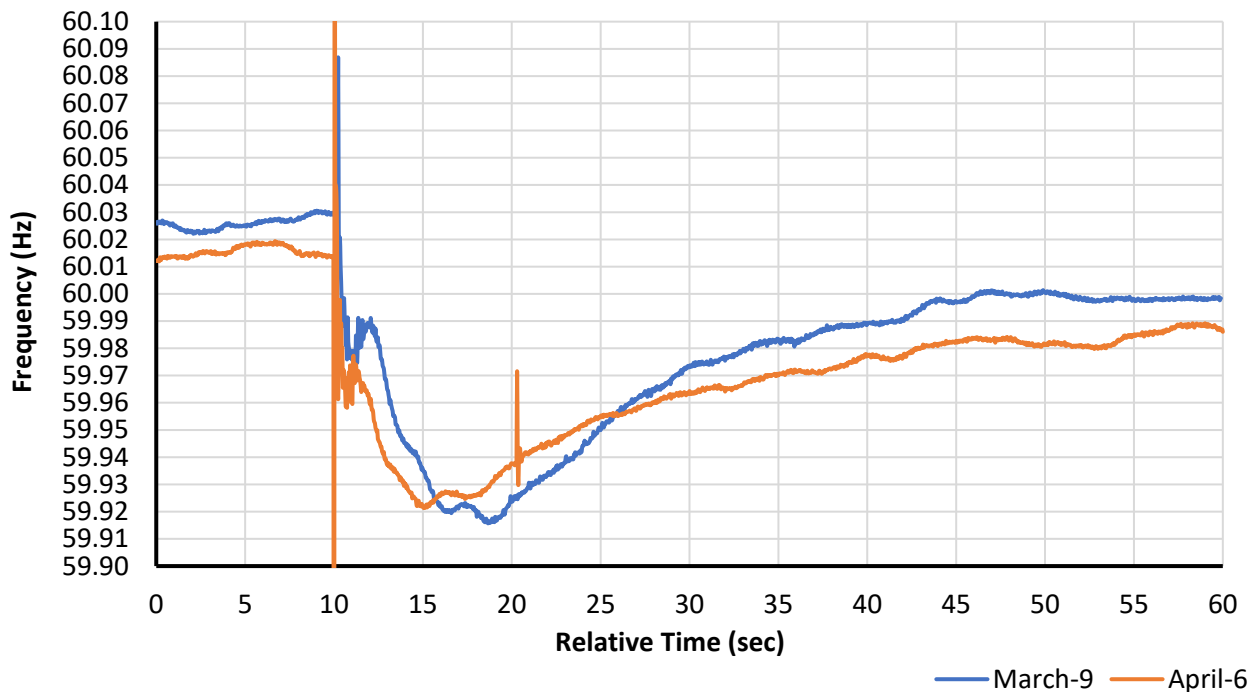
Figure 1.5: WECC System Frequency for Each Disturbance [CAISO]

to 59.916 Hz. CAISO, the Balancing Authority, raised regulating unit output to assist in the recovery of the frequency and ACE. The time from the event start to the frequency nadir was measured at around 12 seconds. System frequency returned to normal in three minutes.

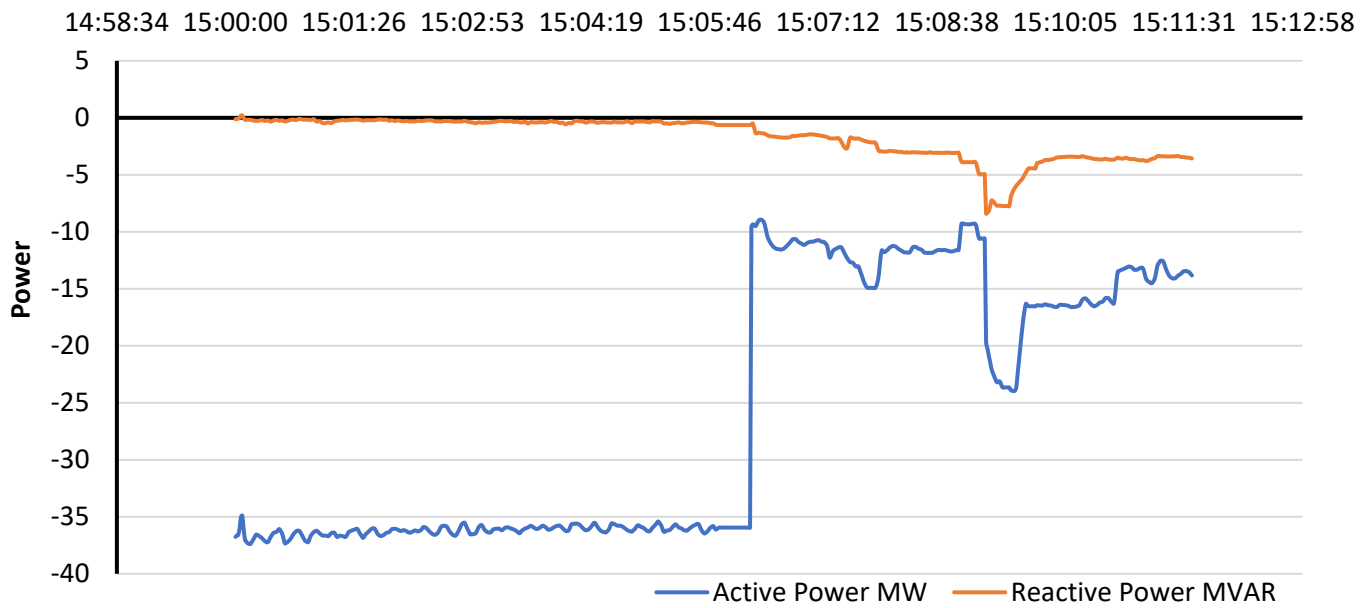
Figure A.4: Plant B Active and Reactive Power at POI on April 6

Plant B is a 115 MW facility connected to the 230 kV network that went into commercial operation in April 2021. The plant output dropped by 26 MW during the event from the pre-disturbance level of 36 MW (see [Figure A.4](#)). The plant consists of a total of 45 inverters. GO reported that five inverters tripped (three tripped on unbalanced ac current protection; cause of trip unknown for the rest). However, the loss of five inverters does not add up to the total 26 MW lost, suggesting that there is a data quality issue.

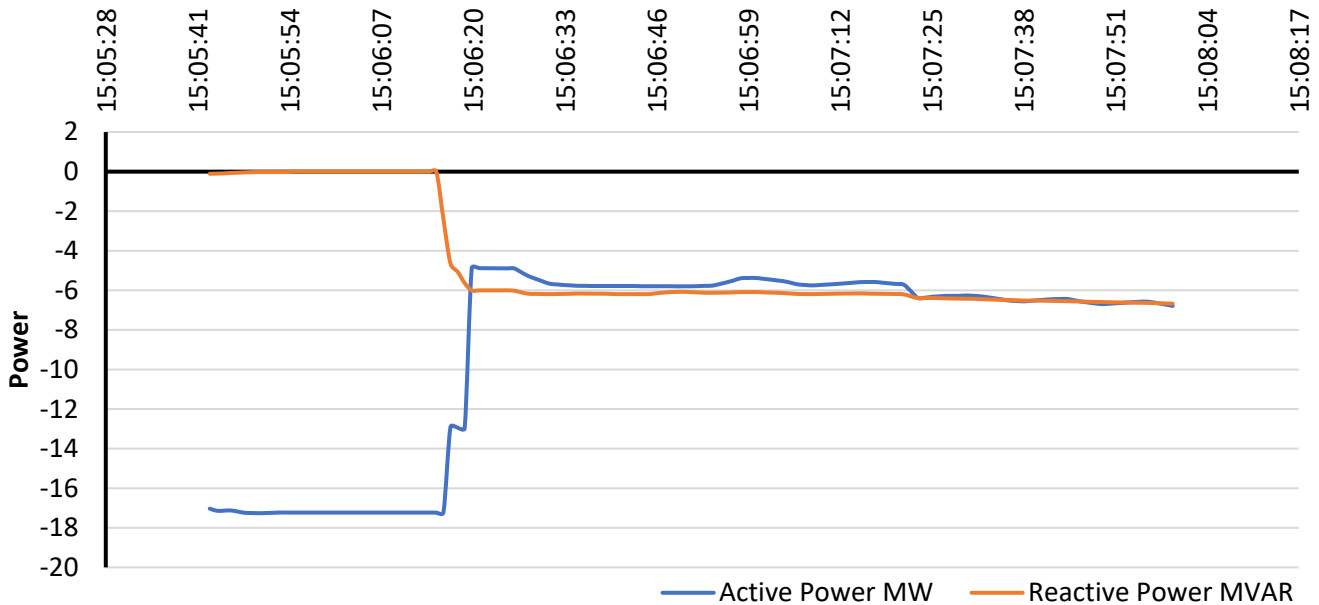
Figure A.5: Plant C Active and Reactive Power at POI on April 6

The GO reported there was no inverter fault and attributed the abnormal power response to the facility charging at a lower power level than the set point to manage the battery nearing its full state of charge. However, data from GO (Figure A.5) indicated that the facility metering was interrupted right around the disturbance due to the log recording the same value for a few seconds. When the recording resumed, the plant charging power level dropped, and the reactive power consumption increased simultaneously, suggesting that a few inverters were lost. The results are inconclusive.

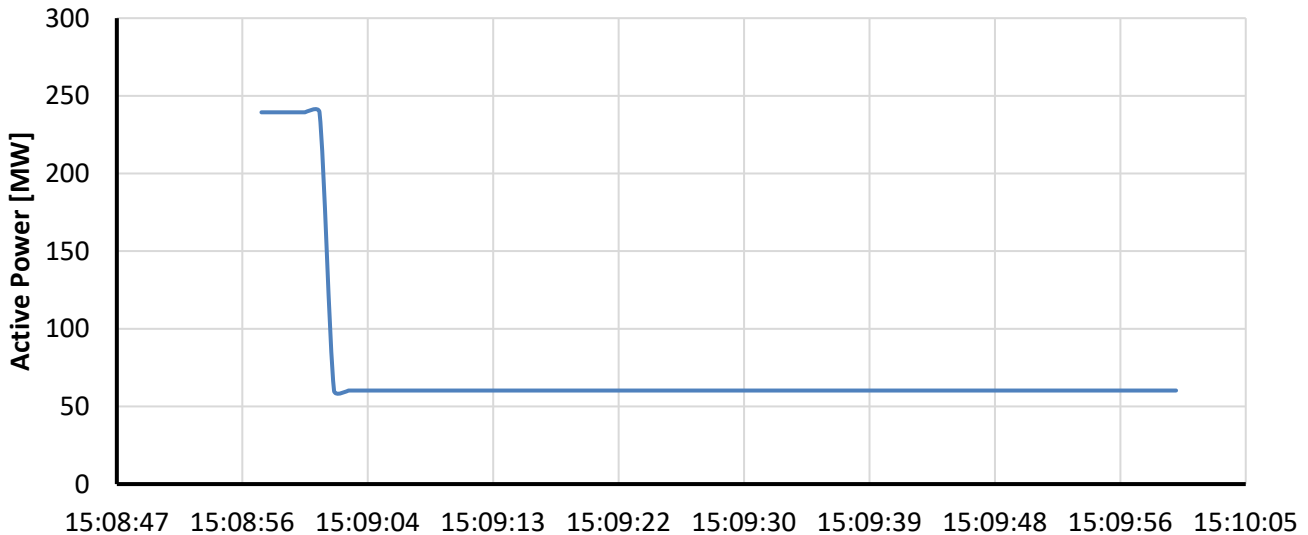
Figure B.3: Plant G Active Power at POI on April 6

Plant G is a 250 MW facility connected to the 230kV network that went into commercial operation in 2016. During the event, the plant output dropped from 239 MW to 60 MW due to 192 inverters tripping on low line-to-line voltage and 2 inverters of a different manufacturer tripping for unknown reasons as the inverters did not record fault codes. A few months prior to the event, the inverter trip settings had been revised from being set directly on PRC-024 no-trip boundaries, but the inverter still tripped. See [Figure B.3](#).

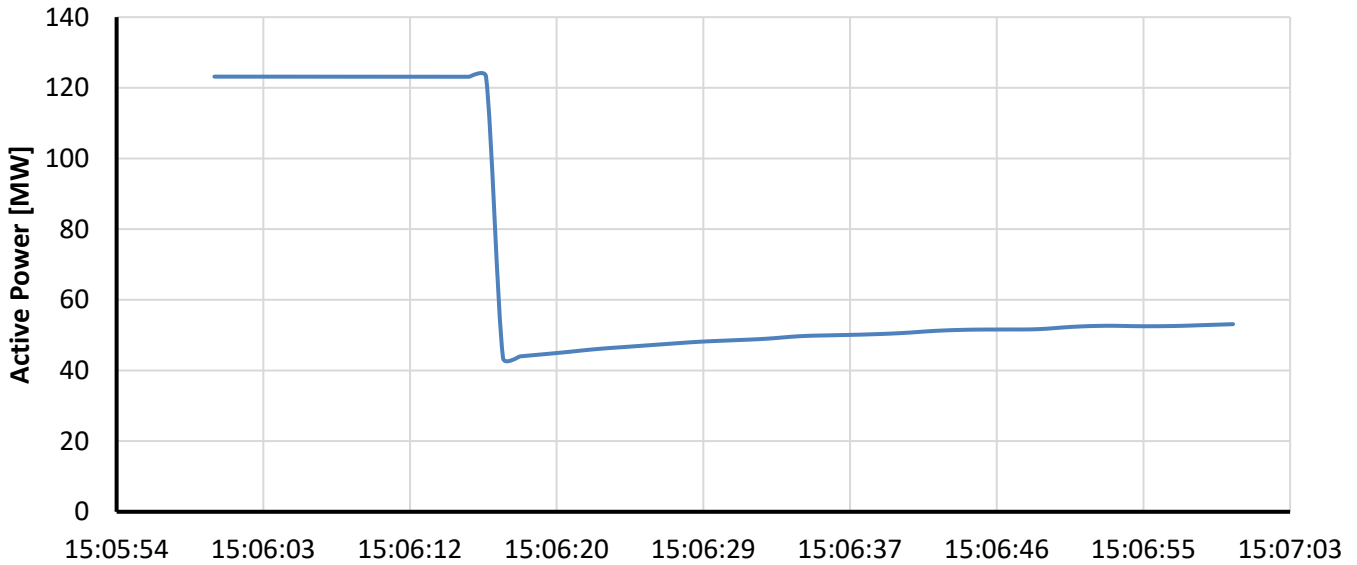
Figure B.4: Plant H Active Power at POI on April 6

Plant H is a 125 MW facility connected to the 230 kV network that went into commercial operation in 2020. During the event, the plant output dropped from 123 MW to 43 MW due to 23 inverters tripping and 3 inverters experiencing partial loss of modules. The causes of tripping included high voltage ac, unbalanced dc bus, and ac overcurrent. See [Figure B.4](#).

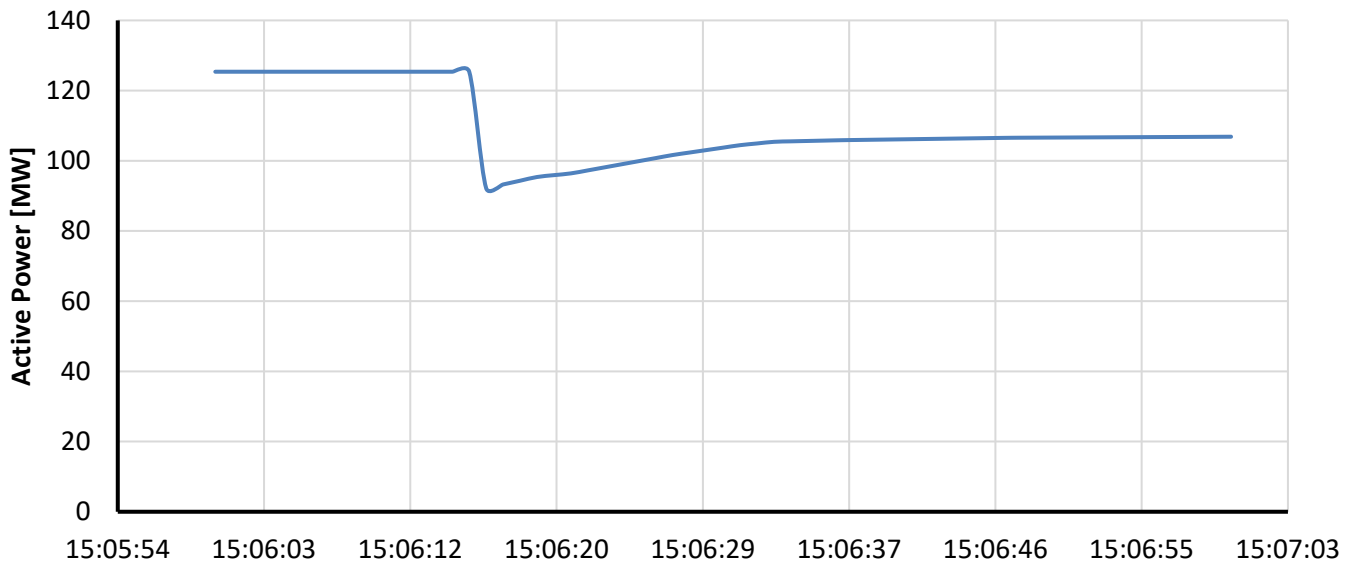
Figure B.5: Plant J Active Power at POI

Plant J is a 125 MW facility connected to the 230 kV network that went into commercial operation in 2020. During the event, the plant output dropped from 125 MW to 92 MW due to 26 inverters experiencing partial module loss and 1 inverter tripping completely. The causes of tripping included unbalanced dc bus and unknown. See [Figure B.5](#).
